DRAINAGE INVESTIGATION FINDINGS

Regarding: Drainage Investigation
Preliminary Findings

Date: August 29, 2023

Proj. No.: 16-3304 Task #17

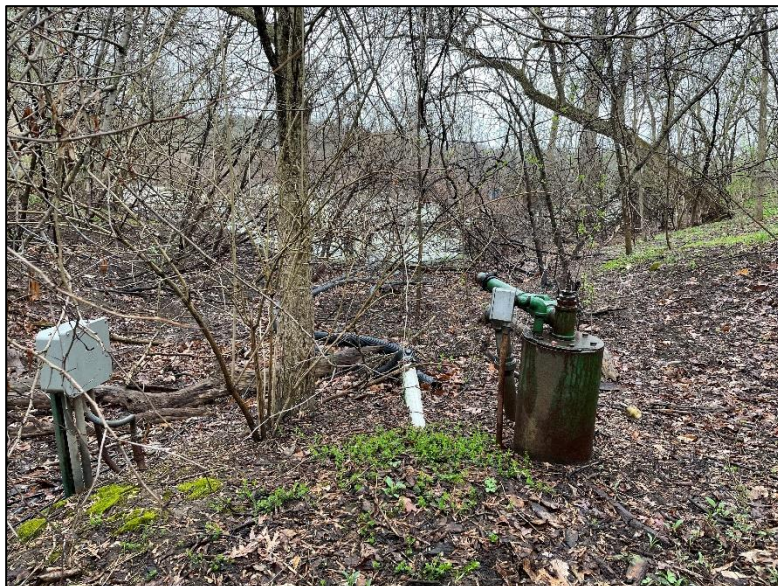
Photo 1 – Picture of pump, facing east towards Lake Lacey

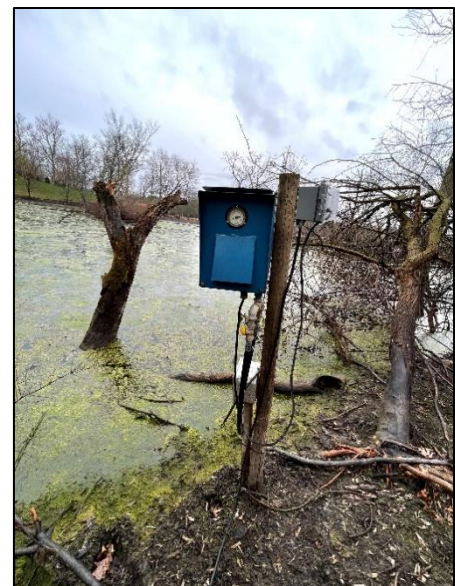
On April 8, 2021 Anitha Dasappa (CCDOH), Steve Cieslica (Trotter), and Jamere Clark (IEI) visited the area of Donlea Road and Lacey Lake in the Village of Barrington Hills. The field investigation began along Donlea Road near the north end of Lacey Lake. The first observation was the existence of a pump just east of Donlea Road with corrugated pipes leading to Lake Lacey (*Photo 1, see also Exhibit A – Overview Map*). A gauge was also located near the lake's edge, that appears to be powered from the same source as the pump (*Photo 2, see also Exhibit A – Overview Map*). The purpose of the pump and gauge is unclear. Trotter Engineering unsuccessfully attempted to contact the property owner to ascertain the function of the devices.

Photo 2 – Unknown pressure gauge instrument at Lake Lacey

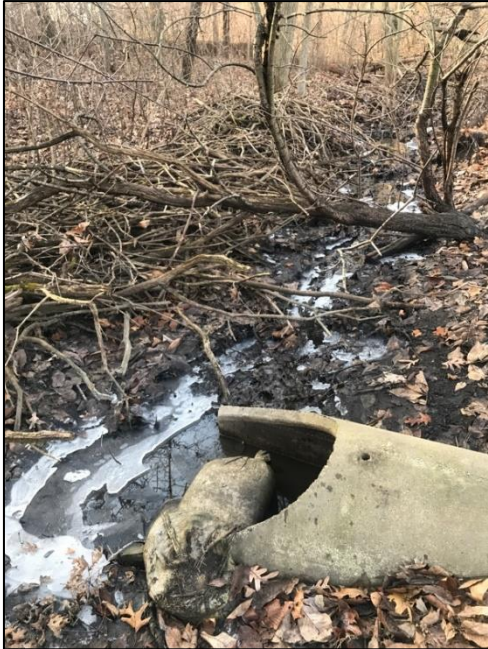
The field reconnaissance continued following the natural drainage path of overflow from Lake Lacey towards Donlea Road. A ditch conveys overflow out of Lacey Lake NW towards Donlea Road. This ditch then turns NNE to run parallel to Donlea Road until it reaches Cook County culvert V46-010 (See *Exhibit B – Contour Map*). This concrete culvert is 15-inches in diameter. The below photos show the drainage ditch flow arriving at the upstream end (east side of Donlea Road).

Photo 3 – Looking south on east side of Donlea Road (upstream end)

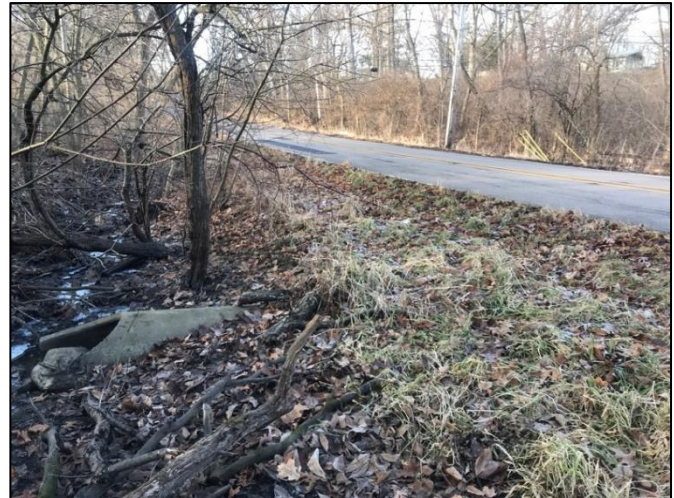
Photo 4 – Looking south on east side of Donlea Road (upstream end)

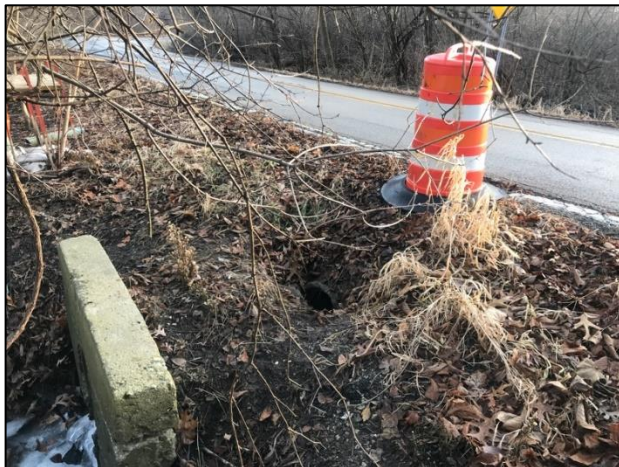
The below photos show the same culvert at the downstream end (west side of Donlea Road). As shown, the culvert needs repair, as a pipe joint has fully separated, causing a void in the ditch.

Photo 5 – Looking north on west side of Donlea Road

(Please note that the four photos on this page were taken December 2019 by IEI during a separate project. IEI verified on November 23, 2022 that the culvert condition remains unchanged.)

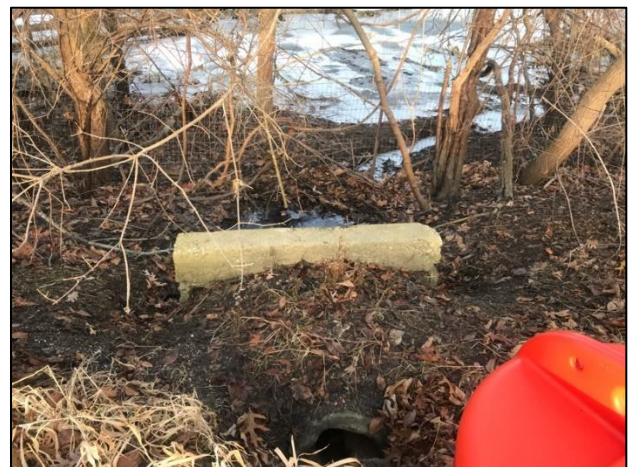
Photo 6 – Looking towards the west in direction of depressional area

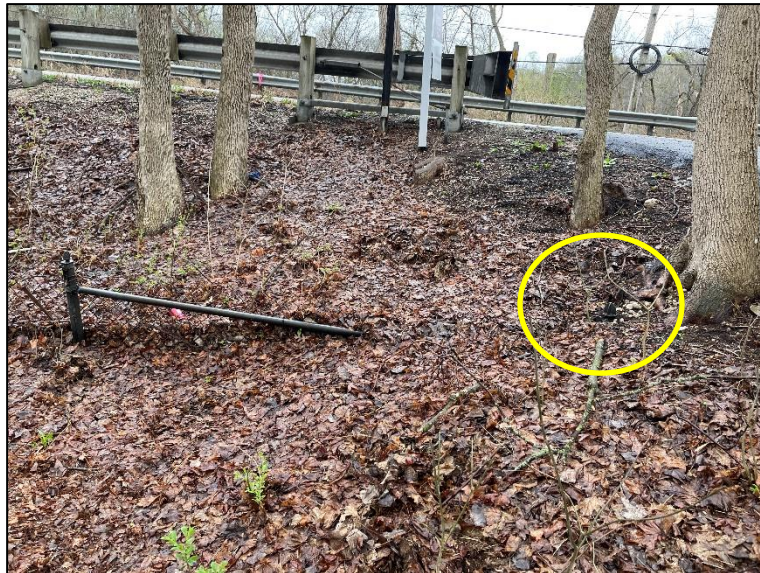
IEI received record drawings from the Illinois Department of Transportation (IDOT) for County Line Road. Locations of the culverts along County Line Road were transposed onto the overview map exhibit. The first culvert, per the records adjacent to the depressional area was identified as culvert 'Station 150+30.' Both ends of this culvert were located in the field. Per survey, the culvert flows from north to south, towards the depressional area. Culvert 'STA 149+80' was not found. The record drawing from IDOT indicated that it was an E-W culvert located on the north side of County Line Road. It appears that the topography of the north side of County Line Road has changed since the road was constructed. A driveway exists presently where we expected to locate culvert 'STA 149+80.' Remnants of a fence along the north side of County Line Road near the driveway suggest the profile of the area was modified. The below picture shows the very top of a fence post circled in yellow. The vantage point is facing south with County Line Road in the background, the driveway where we expected to find culvert 'STA 149+80' to the right.

Photo 7 – Facing south on the north side County Line Road

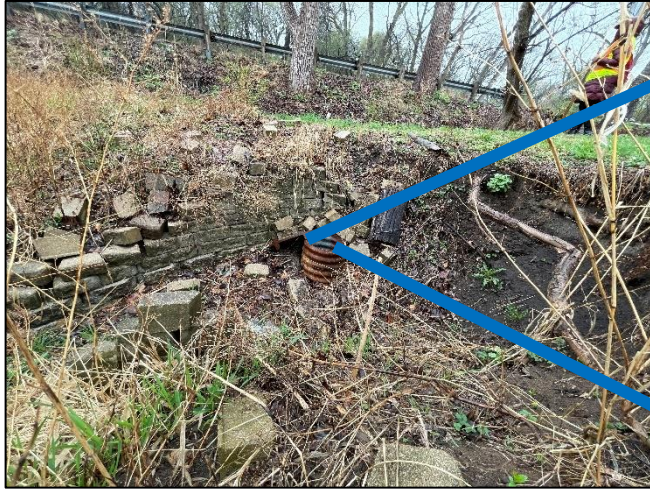
The property at 381 County Line Road has a pond adjacent to the roadway. Analyzing the topography, drainage runoff flows from the west into this pond. There is a control structure located at the NE corner of the pond, as pictured below (Photo 8). There was one pipe observed in the structure (Photo 9). The downstream end of this pipe was located on the east side of the driveway (Photo 10). The control

structure conveys flow east toward the depressional area. The National Wetlands Inventory defined this pond as *PUBGh*, a palustrine system with an unconsolidated bottom. The special modifier "h" stands for wetlands that are diked/impounded. By definition, a diked/impounded wetland is one created or modified by a man-made barrier or dam that obstructs the inflow or outflow of water. The below pictured control structure confirms the NWS special modifier, as the structure restricts outflows.

Photo 8 – Control Structure at NE corner of pond

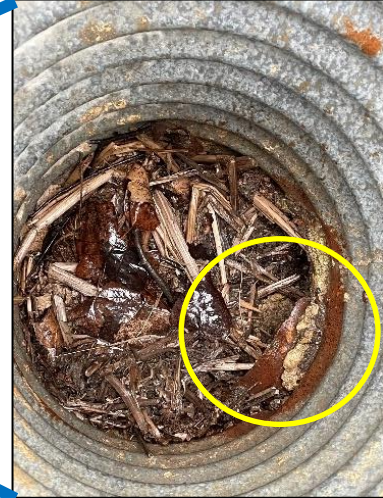
Photo 9 – Inside CMP control structure, SE pipe outlet observed

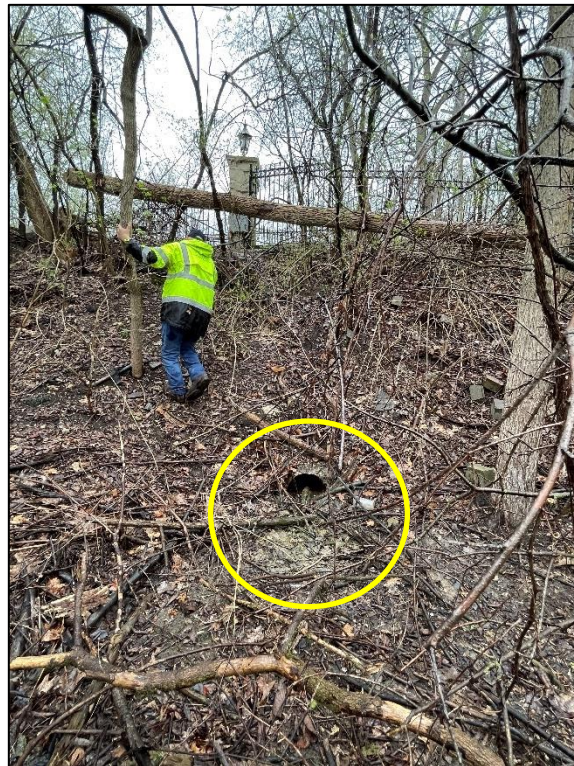
Photo 10 – Outlet pipe from control structure east of driveway for 381 County Line Road
