# Plan Commission Special Meeting AGENDA & NOTICE OF MEETING MONDAY, MAY 20, 2024 6:30 PM

An Application for Approval of Sketch Plan for a Single-Family Subdivision of the property located at 01-06-200-021 and 01-06-200-027 (99 & 101 Bateman Road)

Site Improvements for Varda Development

# PRELIMINARY SITE IMPROVEMENTS **VARDA SUBDIVISION** BARRINGTON HILLS, IL

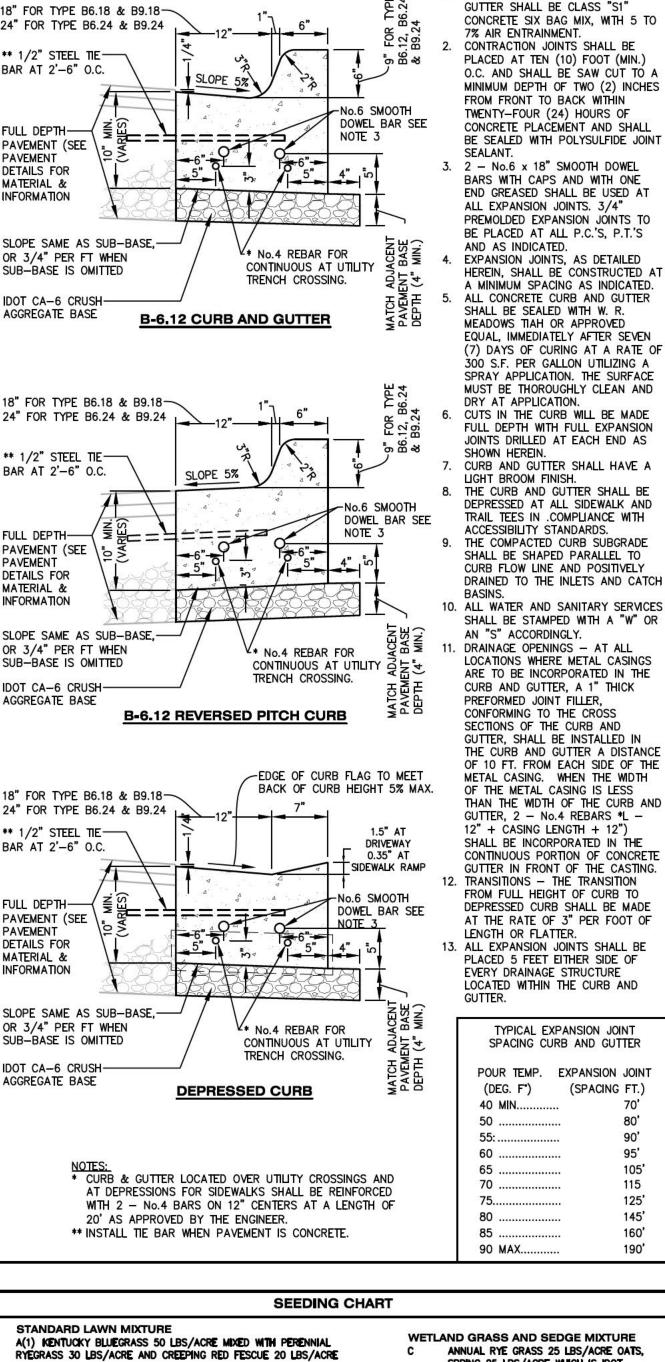
**CONCRETE CURB DETAIL**

ALL CONCRETE FOR CURB AND

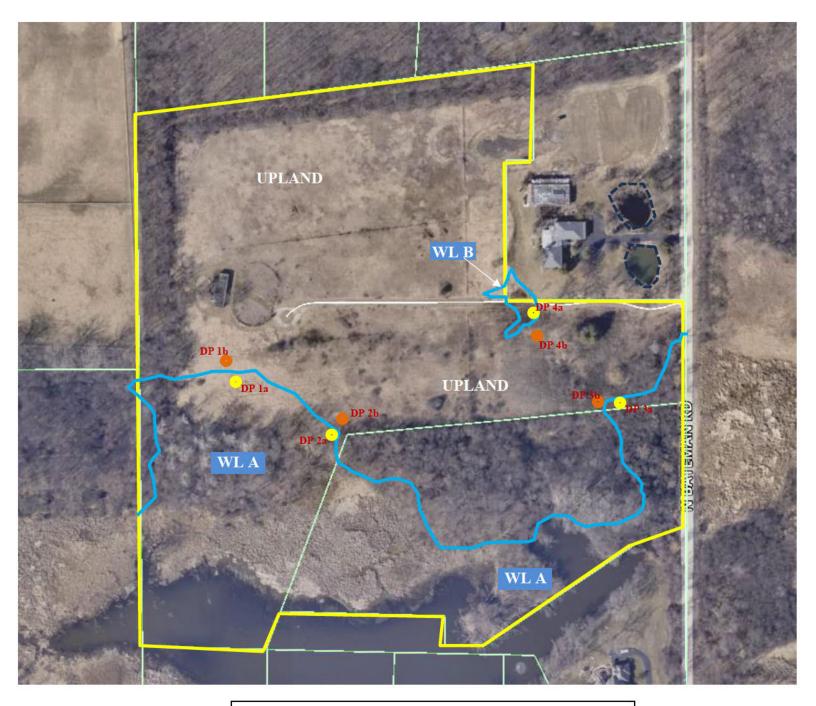
#### **EXHIBIT 7:**

APPROXIMATE WETLAND BOUNDARIES and DATA POINT LOCATIONS

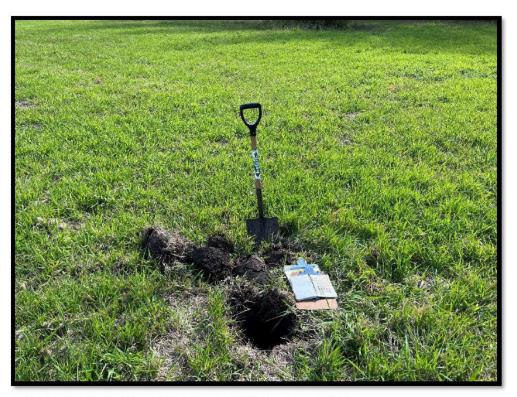
Data Point 1A - Wetland "A" facing SW

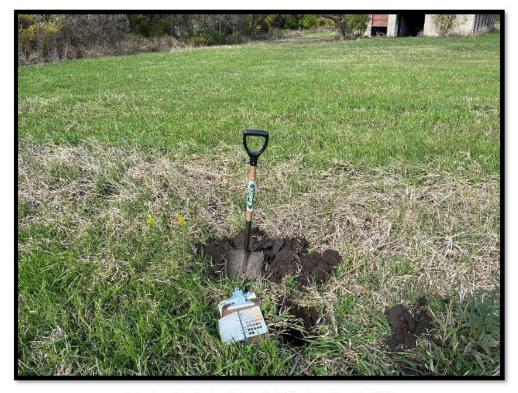
Data Point 1B - UPL facing NW

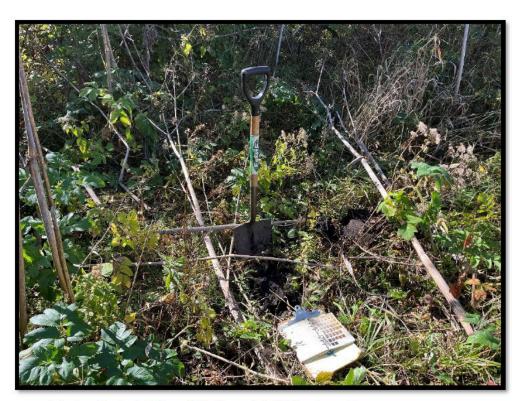
Data Point 2A - Wetland "A" facing S

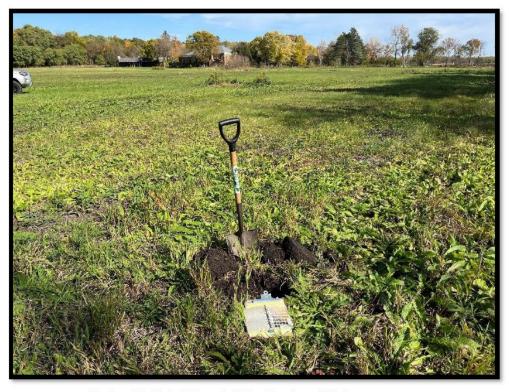
Data Point 2B - UPL facing NE

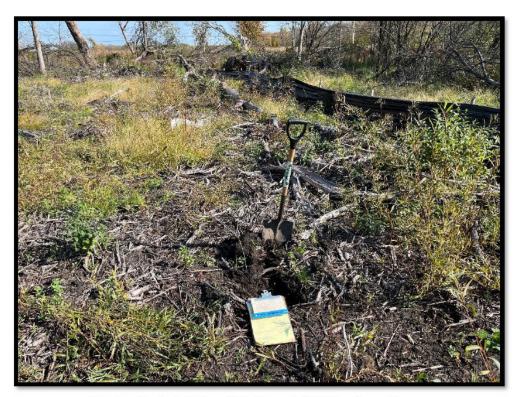
Data Point 3A - Wetland "A" facing E

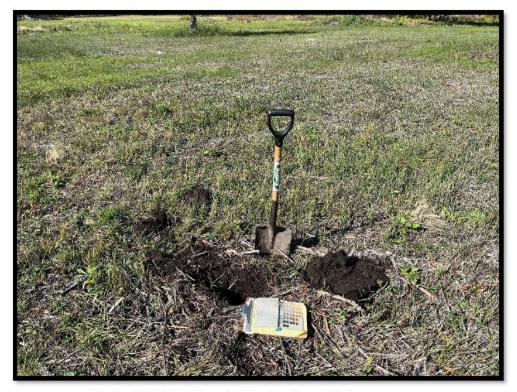
Data Point 3B - UPL facing NE

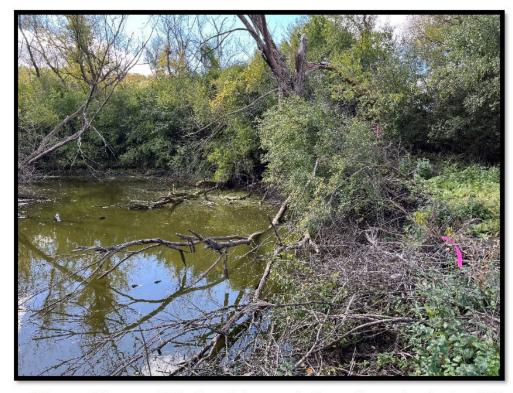
View of flagged Wetland A pond at southeast - facing W

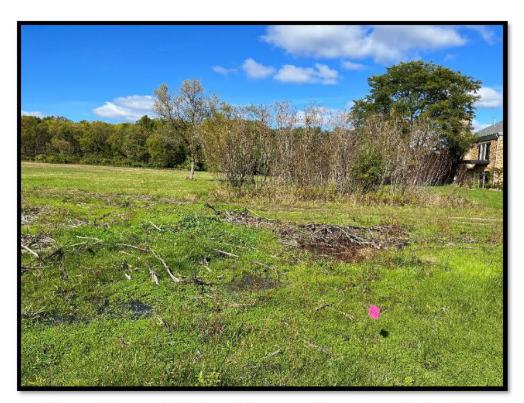
View of flagged Wetland B near driveway - facing N

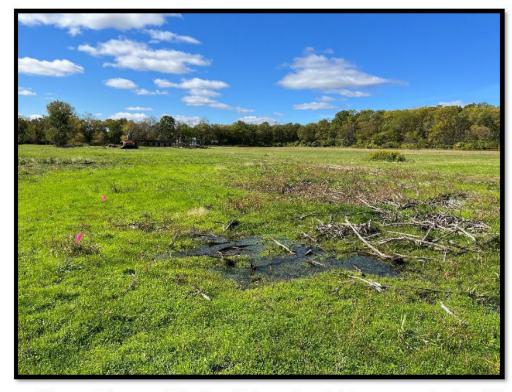
View of flagged Wetland B south of driveway - facing W
