DRAINAGE INVESTIGATION FINDINGS

Regarding: Drainage Investigation
Preliminary Findings

Date: August 29, 2023

Proj. No.: 16-3304 Task #17

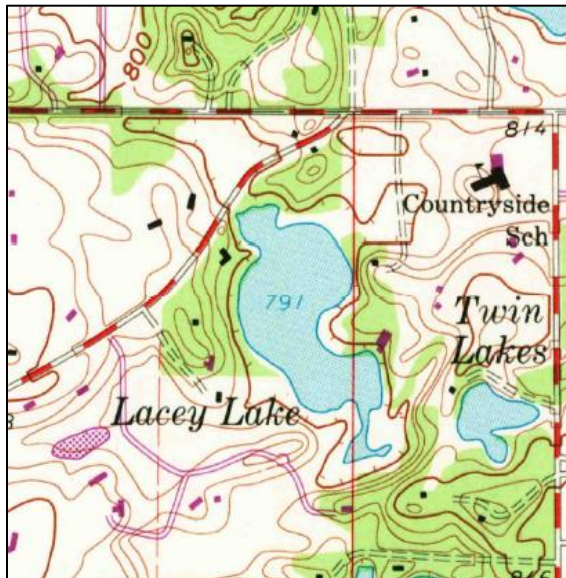
**Figure 1 – USGS Topographic Map 1960
(revised in 1972)**

USGS topographic maps were obtained for this area. The small lake located on the property of 381 County Line Road appears to have formed in the 1970s (See *Figures 1 & 2, below*). Cook County assessor's records show that the home on the property was completed by 1976. Per *Exhibit G – Aerial Photography*, in 1972 no structures existed on the property. In 1974 aerial photo, a home and driveway outpost are both visible. Prior to the 1970's the topography indicates the presently existing pond was within the depressional area located to the east. It appears that the driveway to the home divided the depressional area and formed the pond.
